INDOOR AIR QUALITY ASSESSMENT

**Wildwood Elementary School
71 Strong Street
Amherst, Massachusetts**

Prepared by:
Massachusetts Department of Public Health
Center for Environmental Health
Bureau of Environmental Health Assessment
Emergency Response/Indoor Air Quality Program
July 2004

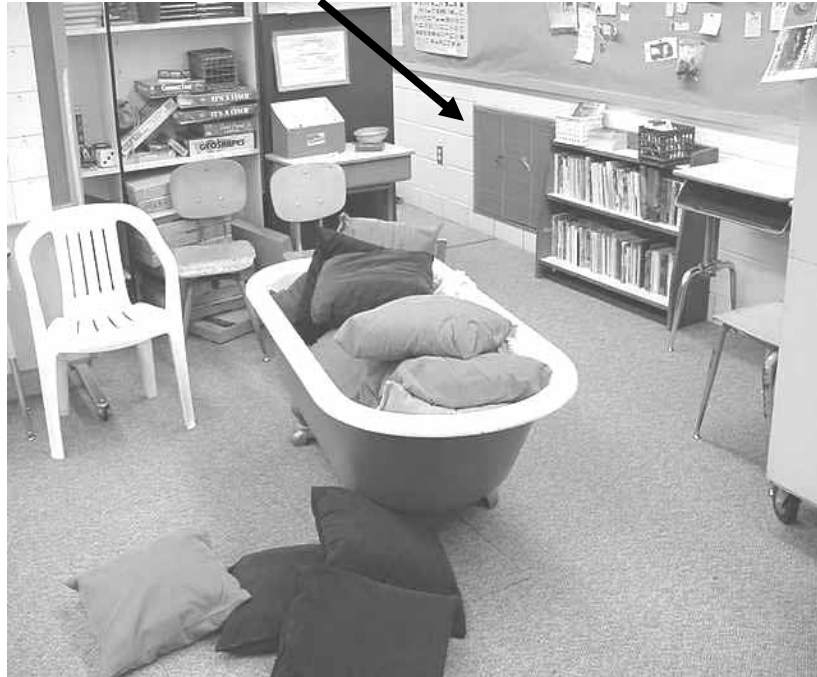
Picture 1

Exhaust ventilation is provided in pods by an exhaust vent located between restrooms, at the farthest point from the hallway (Picture 1). This configuration uses the classroom areas and space between dividing walls as a large duct to exhaust air from the entire pod.

Pod Exhaust Vent

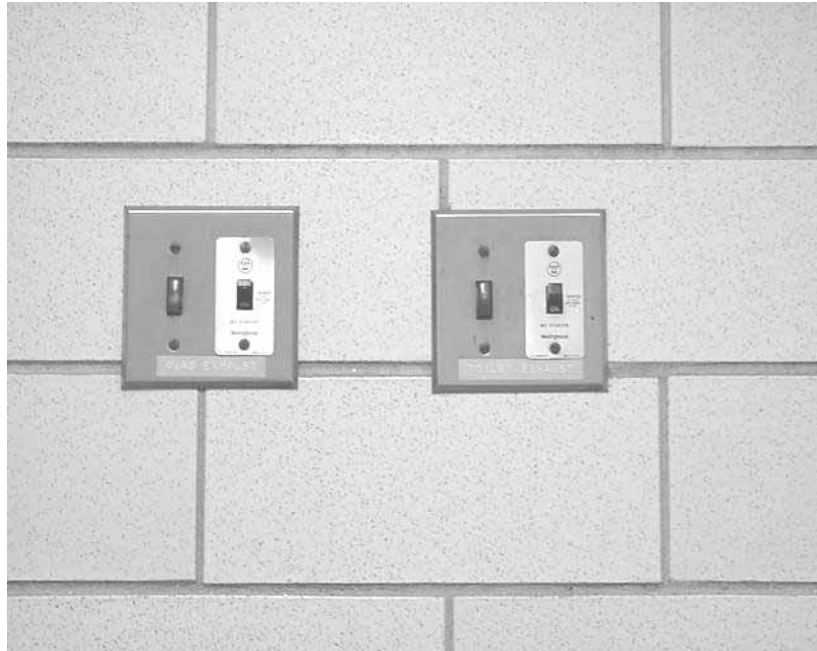
Picture 2

Activation/deactivation of the exhaust ventilation is controlled by a switch located in one of the pod restrooms (Picture 2). The exhaust ventilation in pod C was deactivated and could not be reactivated using the restroom switch, indicating either damage to the switch or the deactivation of a circuit breaker. The exhaust vent in one pod was blocked with stored materials. In order to function properly, these vents must be activated and remain free of obstructions.

**Activation/Deactivation of the Exhaust Ventilation Is Controlled By a Switch
Located in One of the Pod Restrooms**

1. Repair the exhaust ventilation system in pod C.
2. Remove all blockages from univents and exhaust vents.

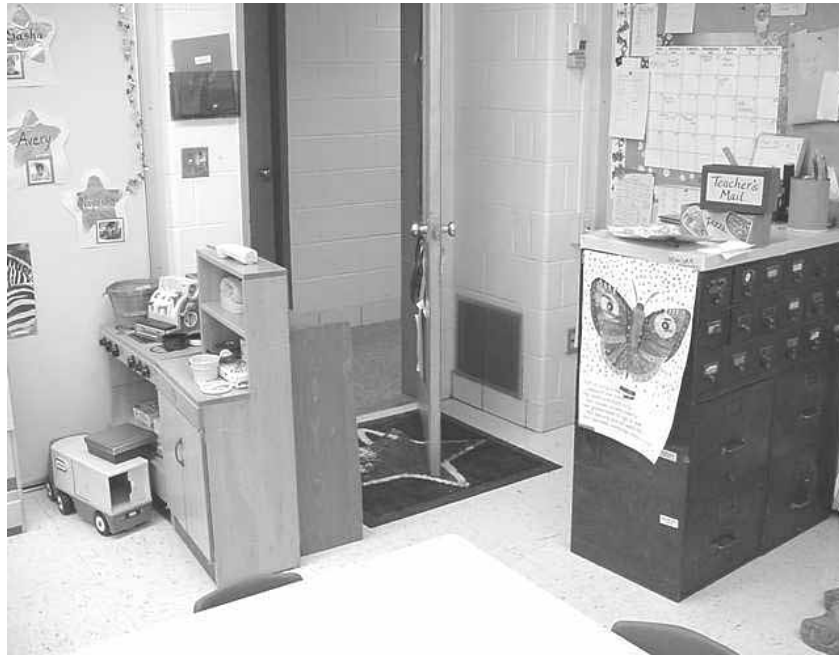
Picture 3

Exhaust ventilation in other areas is provided by wall mounted exhaust grilles. In some areas, these exhaust vents are located behind hall doors (Picture 3). When opened, the hallway door blocks the vent, limiting the ability of the ventilation system to exhaust air. To ensure proper operation of the ventilation system, hallway doors in these areas should remain closed during occupancy.

Exhaust Vents Located Behind Hall Doors

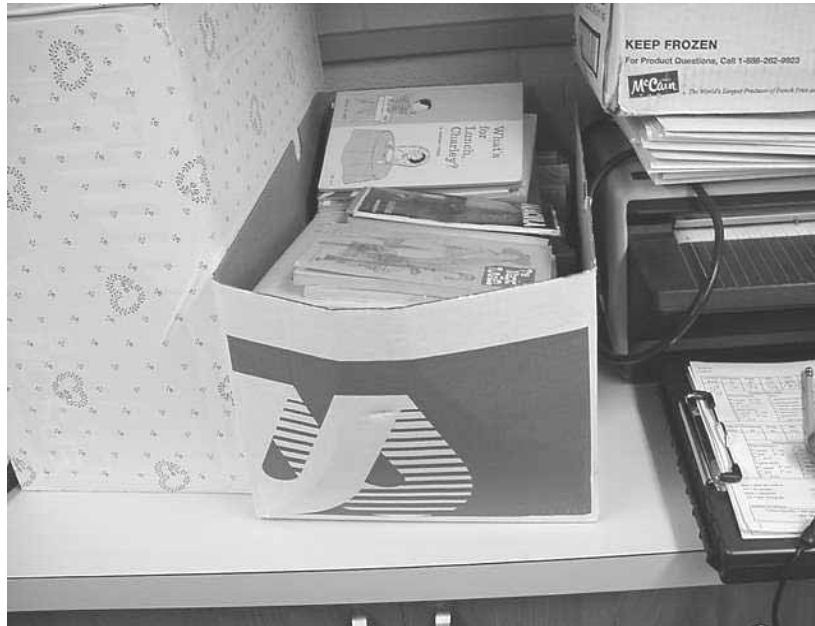
Picture 4a

of the building. The musty odor in this room was traced to a box of paperback books stored on a counter (Picture 4a and 4b). A pungent, musty odor was noted when a book was opened, indicating possible mold colonization of the glue/paste of the book spine or paper. Ventilation alone cannot serve to reduce or eliminate mold growth in these materials. These books will continue to be a source of mold associated particulates. As an initial step, options concerning the preservation of materials stored in this area should be considered. Porous materials that do not warrant preservation, restoration or transfer to another media (e.g., microfiche or computer scanning) should be discarded. Where stored materials are to be preserved, restored or otherwise handled, an evaluation to determine the feasibility of preservation should be conducted by a professional book/records conservator. This process can be rather expensive and may be considered for conservation of irreplaceable documents that are colonized with mold. Due to the cost of book conservation, disposal or replacement of moldy materials may be the most economically feasible option.

Box That Was Source of Musty Odor in the Faculty Work Room

7. Reduce/trim or remove plants that are growing against the exterior brick curtain wall.
8. Discard moldy books and box in faculty work room.
9. Remove carpeting up to three feet from the threshold of exterior doors. Replace carpeting with a non-slip, nonporous material (e.g., rubber matting, tile).

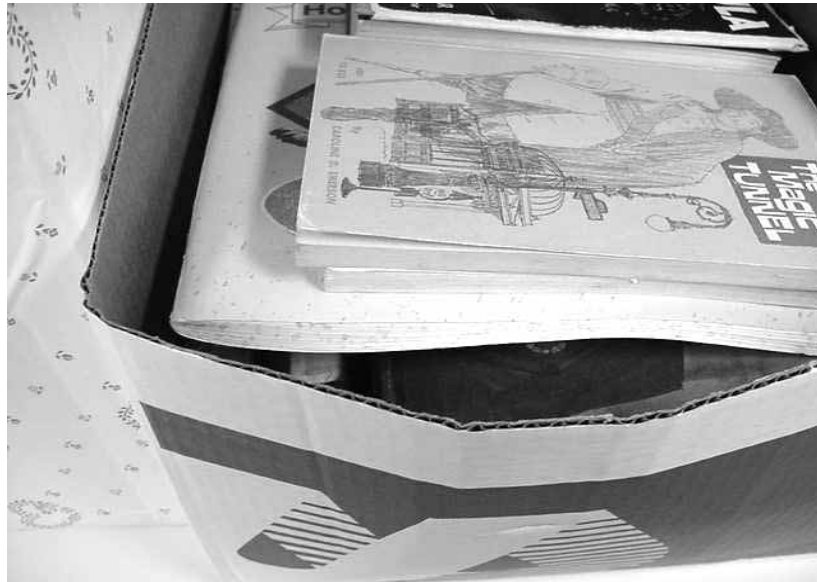
Picture 4b

Close-Up of Books in Picture 4, Note Water Stains and Possible Mold Colonies on Book

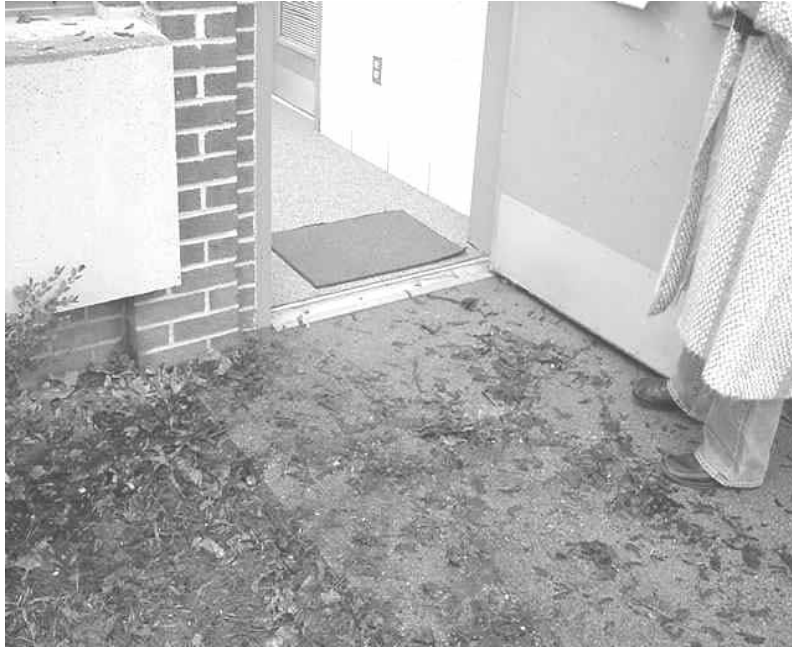
Picture 6

Of note is the wall-to-wall carpeting in classroom areas, which is installed against the threshold of exterior doors (Picture 6). Water damage to the doorframes indicates that carpeting installed around the threshold may become moistened regularly, most likely during wind-driven rain or drifting snow. The gutter system is designed to direct rainwater to roll down the exterior wall, collect at the base and drain away from the building. This design is problematic because tarmac/cement slabs used as exterior door thresholds cause the rainwater to splash. Splashing rainwater can lead to chronic moistening of the exterior wall and doors, which in turn moistens carpet installed against the doorframe. Mold colonization of the carpet can occur from repeated moistening. As discussed, if porous materials (e.g., carpeting) are not dried within 24-48 hours, mold growth may occur.

Carpeting in Class Areas, Which Was Installed Against the Threshold of Exterior Doors

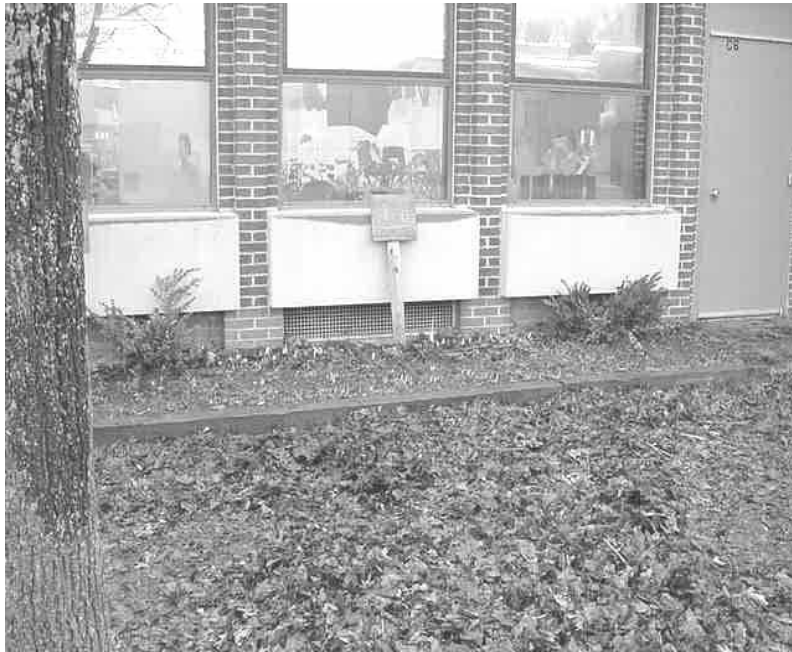
Classroom with Garden Located near the Fresh Air Intake of the Univent

11. Move garden in Picture 7 at least five feet away from univent fresh air intake.

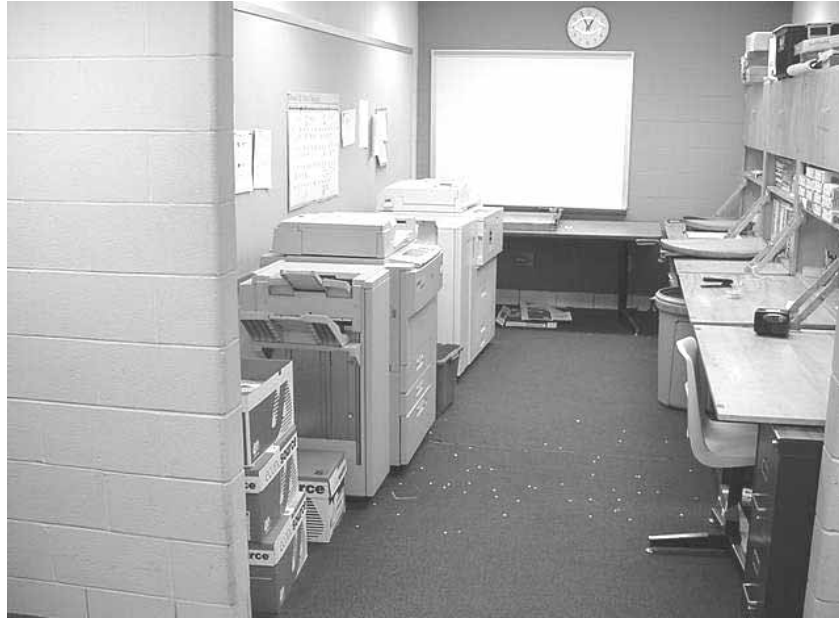
Picture 8

Photocopier Cul-de-sac

15. Examine the feasibility of installing exhaust ventilation for the photocopier area in the faculty work room.
16. Relocate or consider reducing the amount of materials stored in classrooms to allow for more thorough cleaning. Clean items regularly with a wet cloth or sponge to prevent excessive dust build-up.

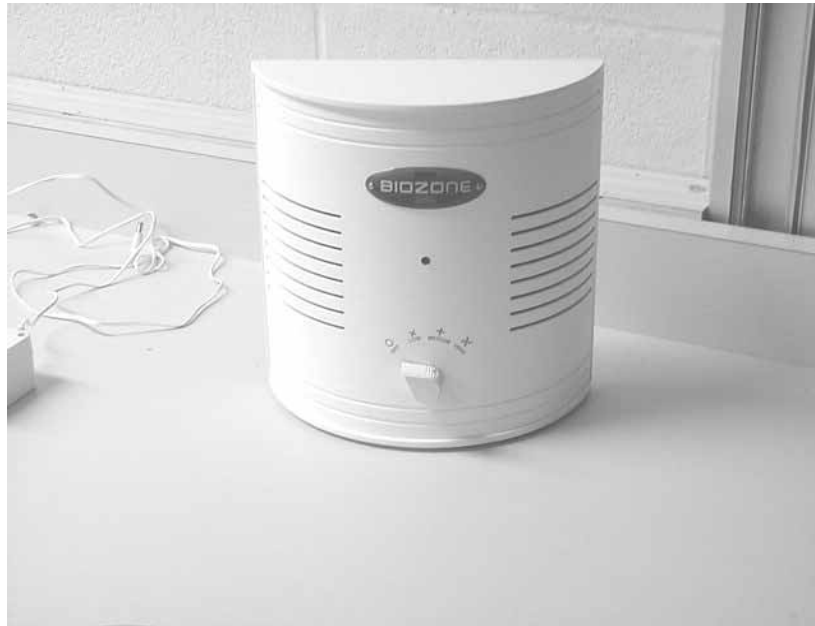
Picture 10a

A pungent, acrid odor was noted in the music room. An air purifier (Biozone 2000 Room Air Purifier) was operating within this room (Pictures 10a and 10b). The Biozone 2000 Room Air Purifier is an ozone generating air purifier (PeakPureAir.com, 2004). At this time, the efficacy of ozone as an indoor air cleaner is being examined by several government agencies. While ozone may be effective in removing some odors of biological origin (e.g. skunk), its use as a universal air cleaner has not been established (US EPA, 2003). As discussed, ozone is a

Biozone 2000 Room Air Purifier

12. Clean accumulated debris in univent drip pans and fresh air intake vents.
13. Maintain aquariums to prevent bacteria, mold and associated odors.
14. Consider discontinuing the use of the ozone generating air purifier.

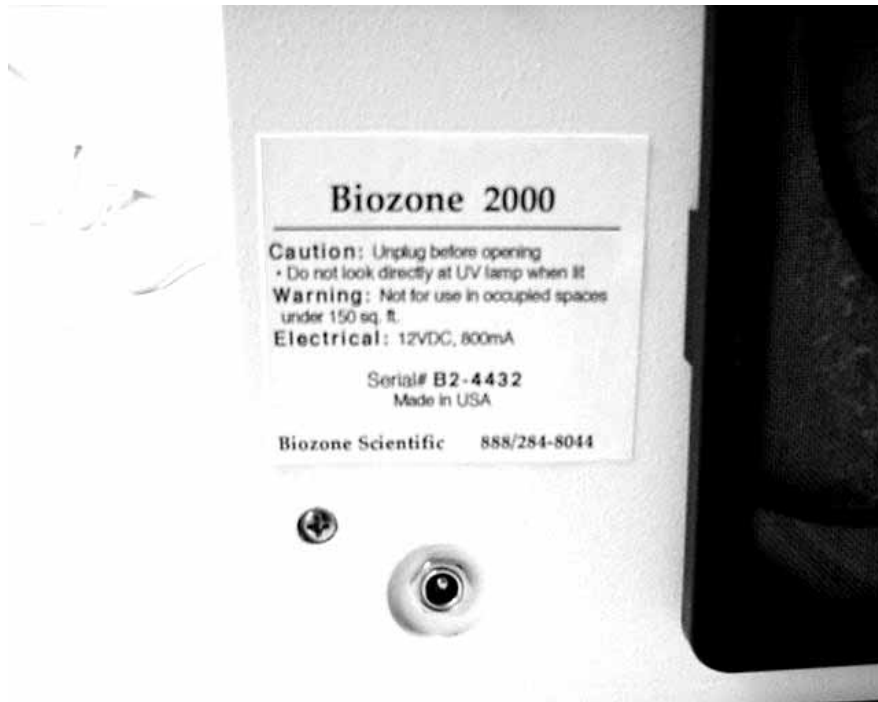
Picture 10b

highly irritating substance to the respiratory system. Until more definitive information becomes available, the use of ozone generators in occupied areas should be done with caution. Please note that the label for this device warns that it should not be “used in occupied spaces under 150 sq. ft.”

Warning Label On Back Of Biozone 2000 Room Air Purifier
